## New York Construction

### Cover Story - July 2006

#### Restoration Challenges

*Contractors and Designers Face Tall Order to Preserve Historic Details*

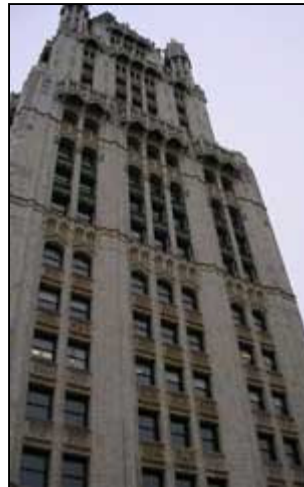
An analysis of the 60-story landmark building's envelope tallied approximately 2,000 cracked and delaminated stones up to 3 sq. ft. in size, as well as unsealed joints on the copper mansard roofs, said Jeff Smith, project manager for Seaboard.

"We're recreating hundreds of different types of terra-cotta stone, some of which are badly deteriorated," he added. "In some cases, we can use a similar piece to make a mold. In others, we have to get a little artistic, while also staying historically accurate." The \$5.25 million, 18-month project also calls for a high degree of logistical detail, Smith said.

"We have to catalog and track the location of every stone and coordinate the status of replacement pieces with the stone fabricator," he said. "That also means coordinating with the architect to ensure that the replacement piece matches the appearance of the original when we pin it to the façade."
